# FORMOSA PLASTICS CORPORATION, TEXAS

Traffic Pellet/Powder Observations  
Gate 2 Road

Conducted: February 22, 2016

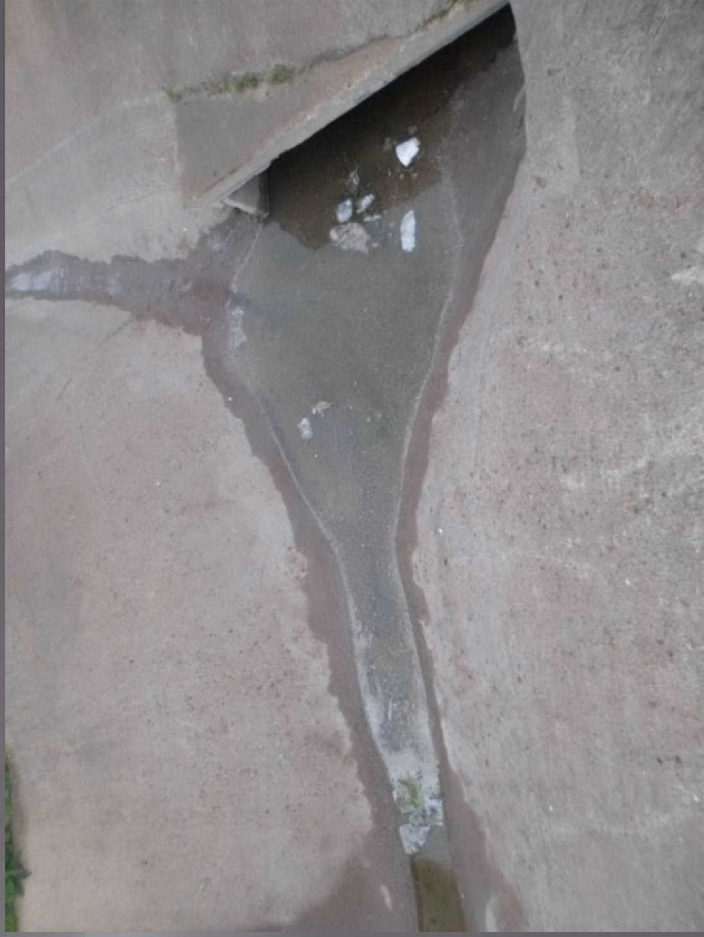
PELLETS AND TRASH ARE VISIBLE IN THIS AREA.

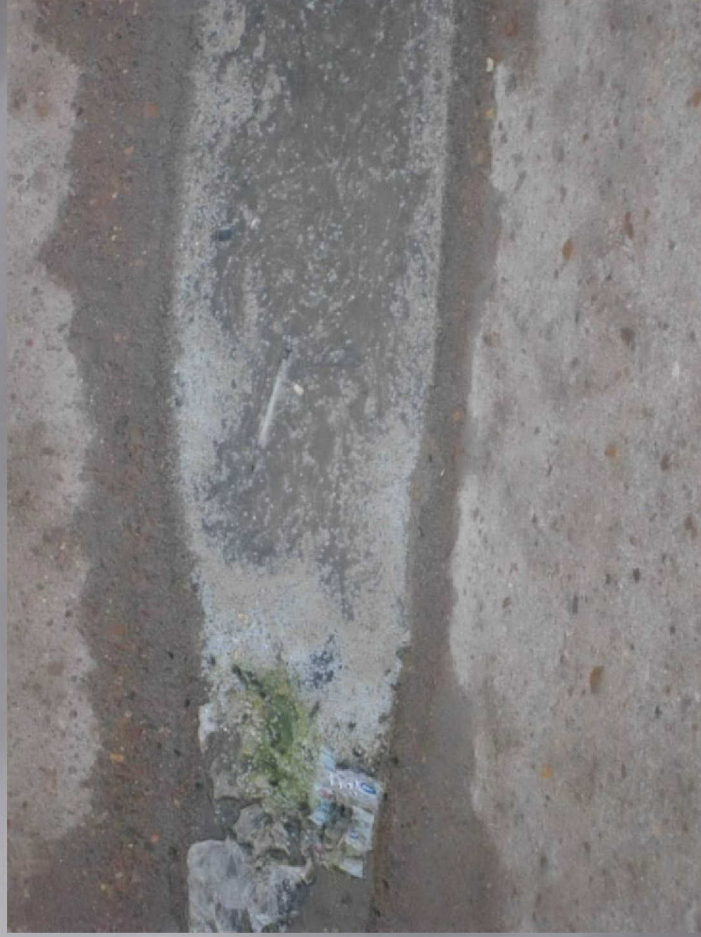
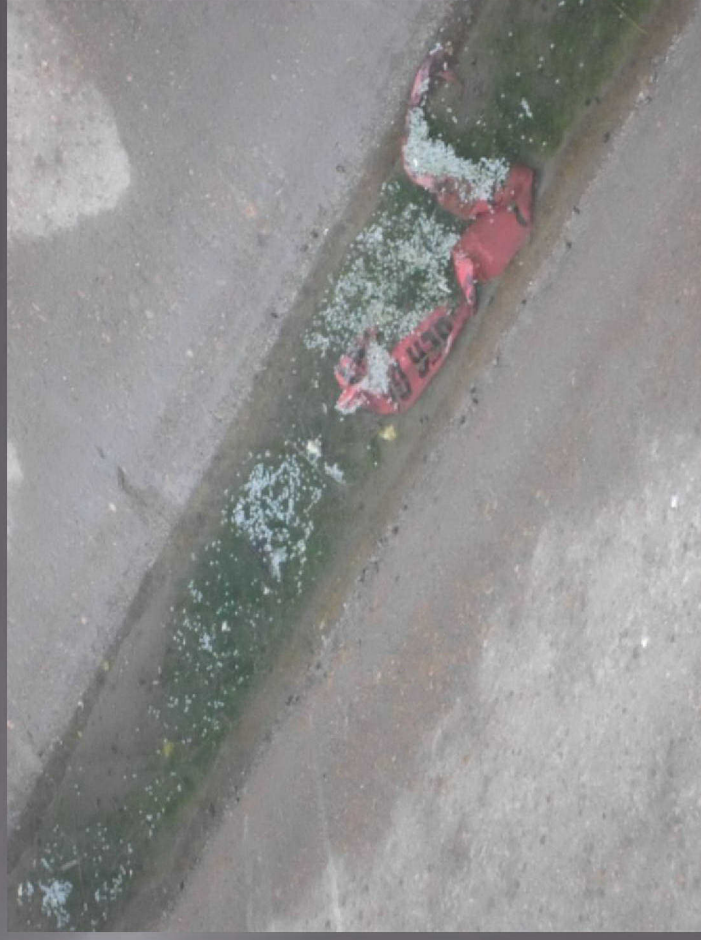
- ▣ PE1/PP1 BAGGING/SHIPPING:
  - Northeast corner, pellets and powder observed
  - Pile of pellets observed on pavement by Roll off box in truck loading area.
  - Weir area, pellets are observed in the sump.
- ▣ HDPE 1:
  - Southeast corner of process area upstream of gate, pellets are visible.
  - Downstream of gate pellets are visible on pavement.
- ▣ LLDPE BAGGING/SHIPPING:
  - Southwest corner of truck loading area, pellets are observed along the dike wall.

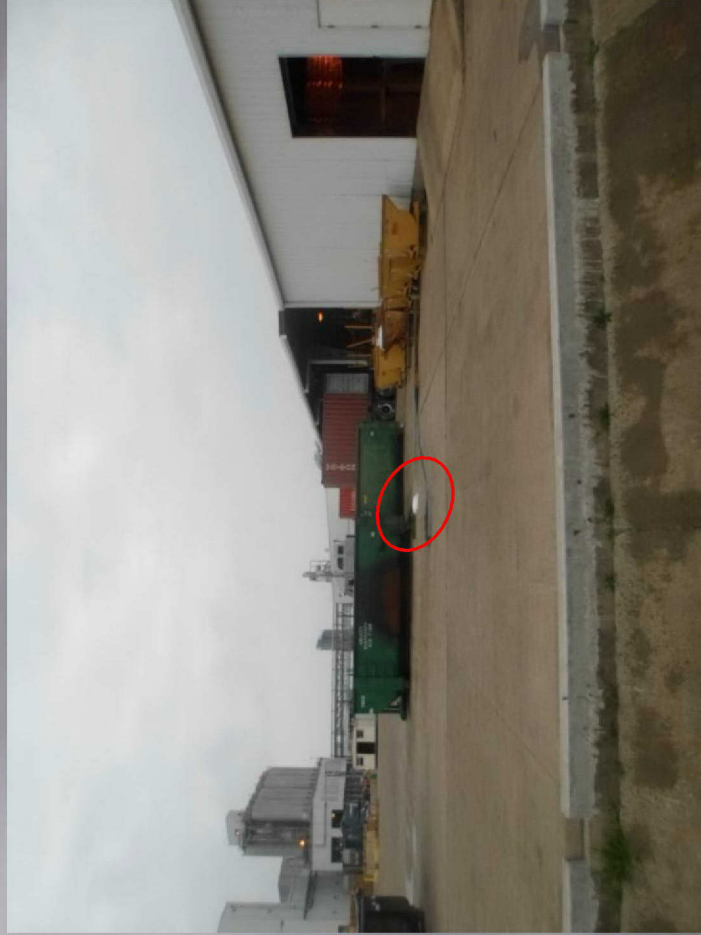
PELLETS OBSERVED BY ROLL OFF BOX. REFER TO NEXT  
PHOTO FOR CLOSER IMAGE.

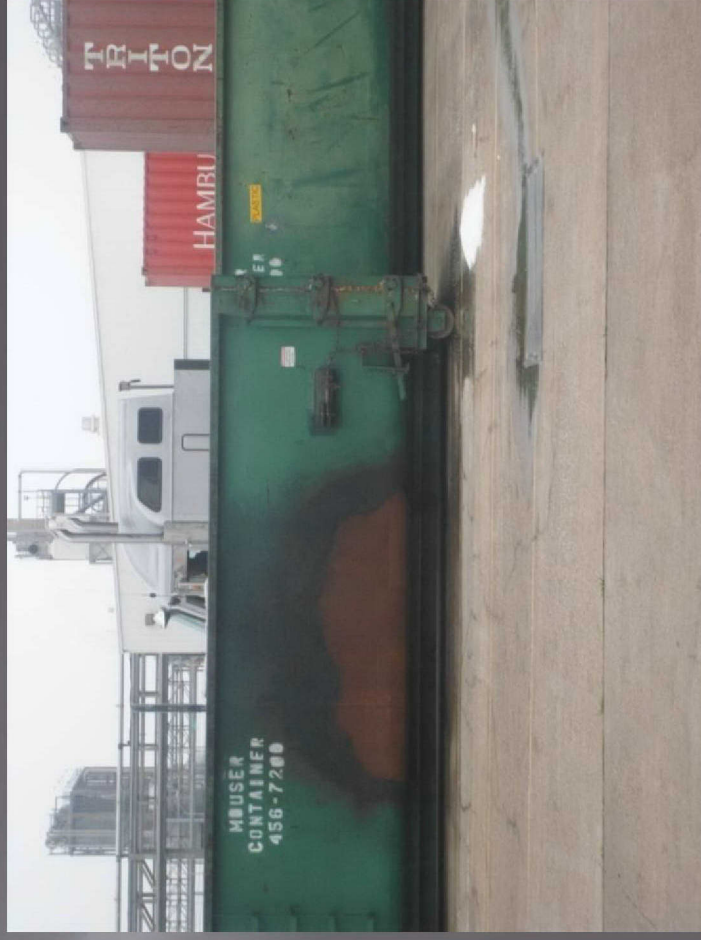
CLOSER IMAGE OF PELLETS ON PAVEMENT.

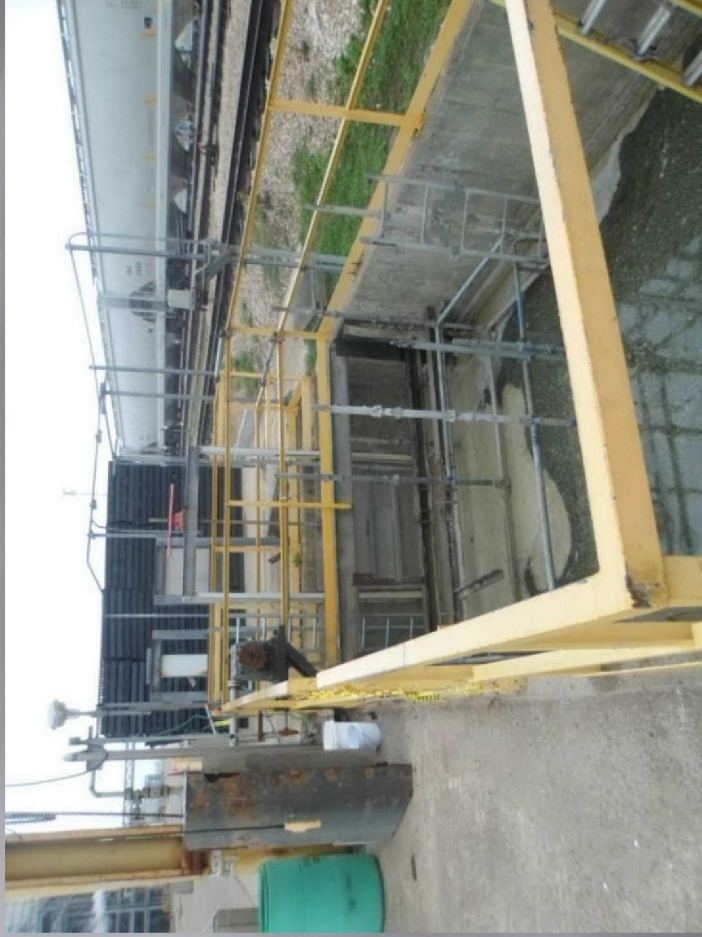
WORK IS UNDERWAY FOR THE WEIR. PELLETS ARE ACCUMULATING IN THE SUMP AREA. NOTE : GATE DOWNSTREAM OF THE SUMP AREA IS CLOSED KEEPING PELLETS CONTAINED.

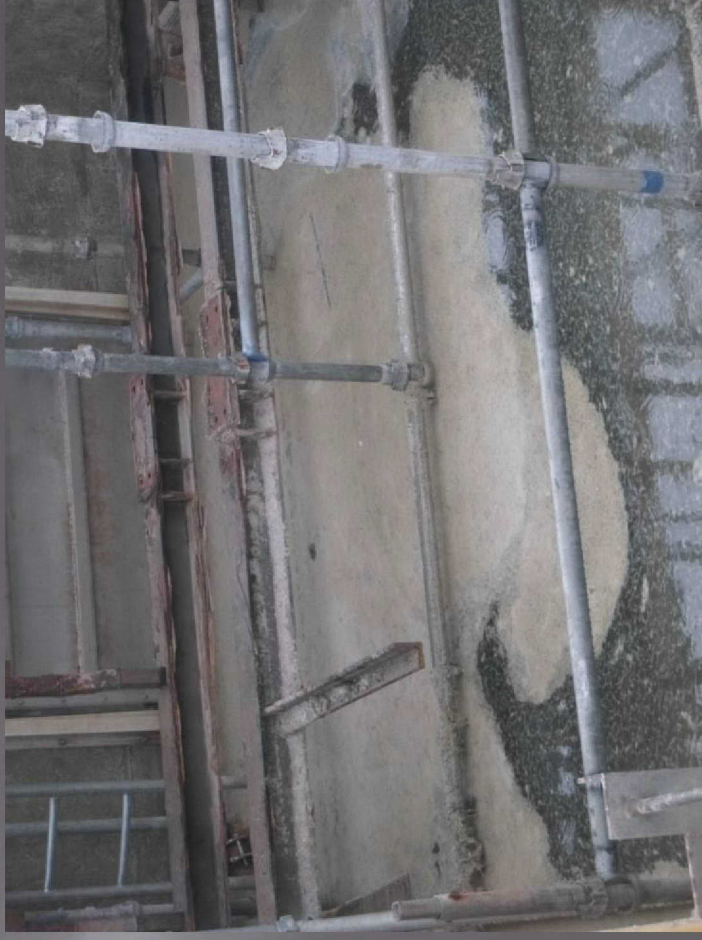
CLOSER IMAGE OF PELLETS.

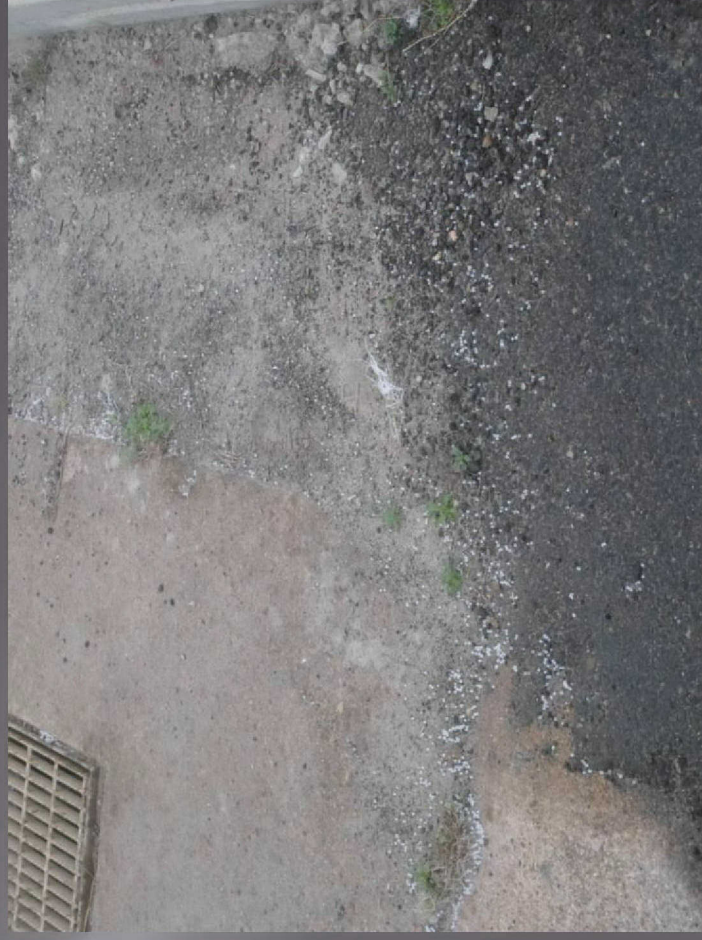
PELLETS LOCATED JUST DOWNSTREAM OF GATE 001.

THIS AREA IS LOCATED JUST NORTH OF THE PE1/PP1 BAGGING SHIPPING AREA (REFER TO SLIDES 3 & 4). CLOSER IMAGES REVEAL THAT PELLETS ARE VISIBLE ON PAVEMENT JUST OUTSIDE OF THE CONTAINMENT AREA. ALTHOUGH CURRENTLY THERE ARE NOT HEAVY RAINS, THE POTENTIAL FOR PELLET OVERFLOW DOWN STREAM OF THE GATE IN A HEAVY RAINFALL IS LIKELY.

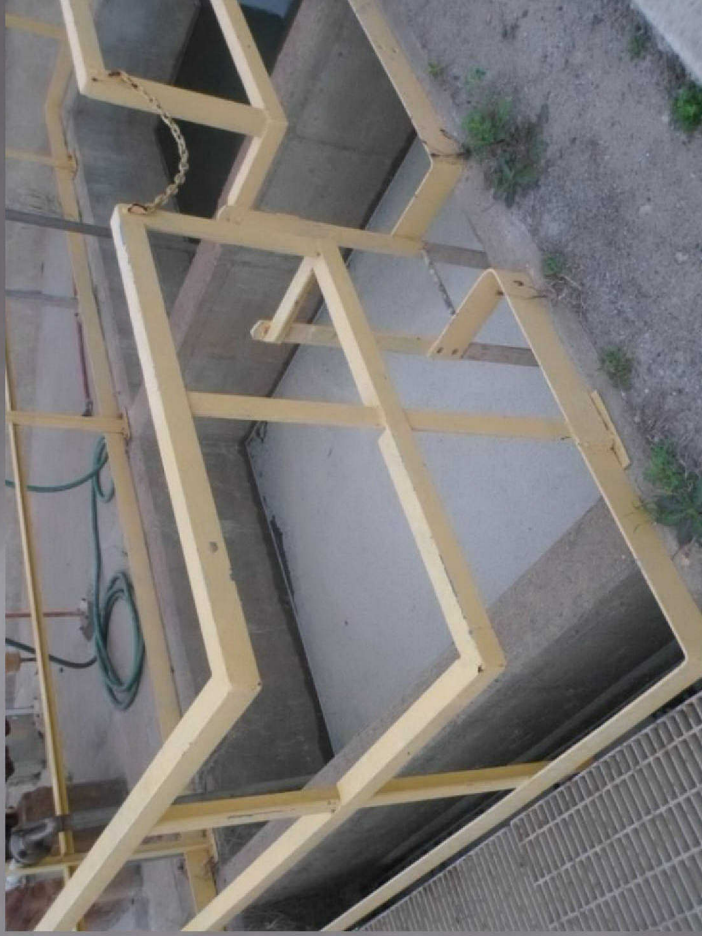
VISUAL OF THE SUMP JUST UPSTREAM OF GATE 001. NOTE THERE IS PIPING ATTACHED INTO THIS AREA TO REMOVE PELLET/WATER AND RETURN TO PROCESS AREA.

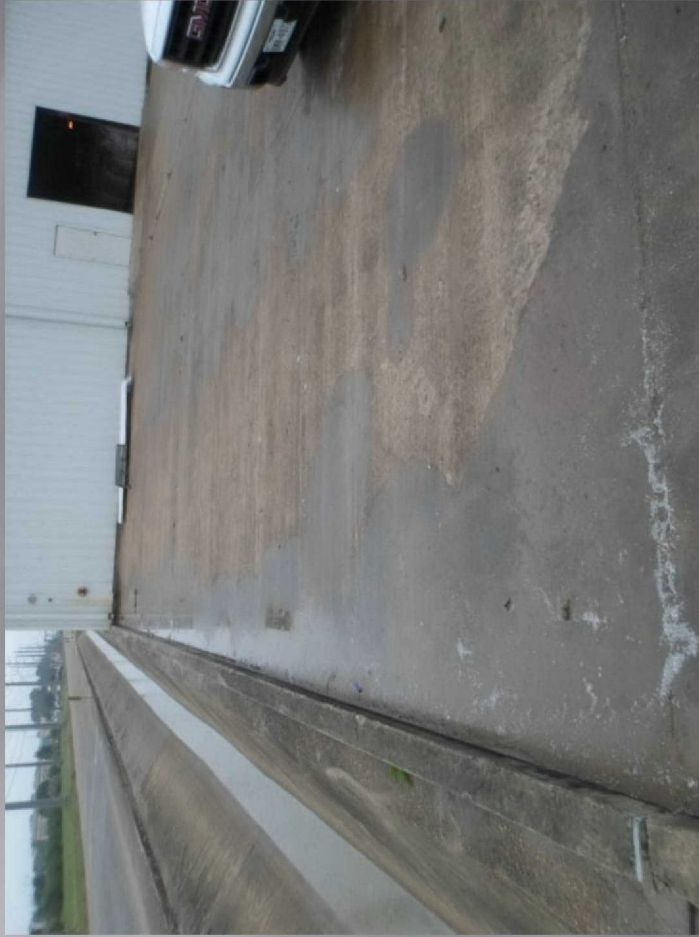
SOUTHWEST CORNER OF THE BAGGING SHIPPING AREA.  
PELLETS ARE VISIBLE ALONG THE DIKE IN THIS AREA.

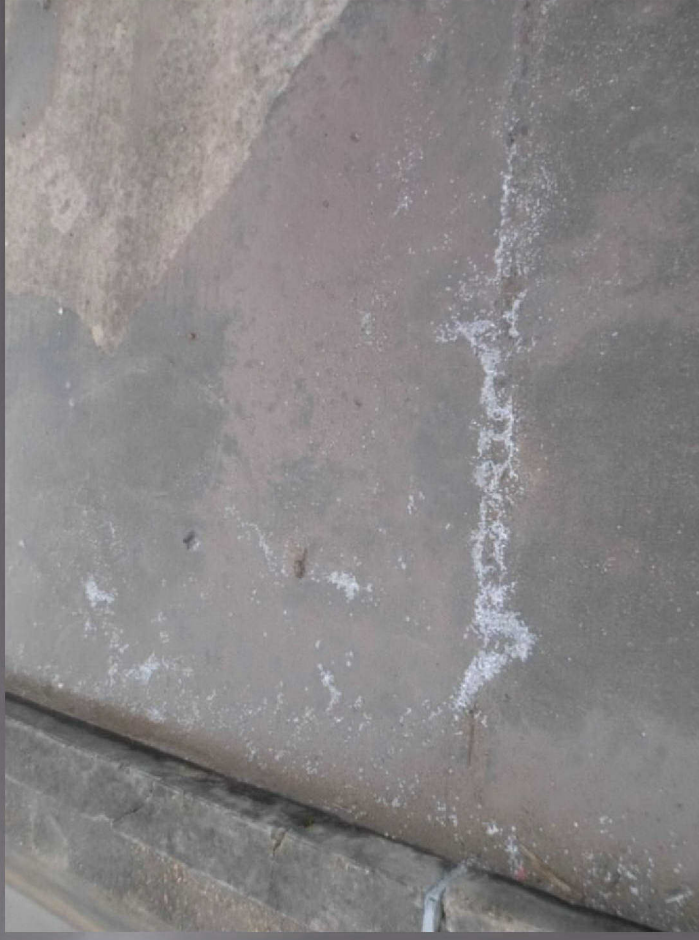
CLOSER IMAGE OF PELLETS.

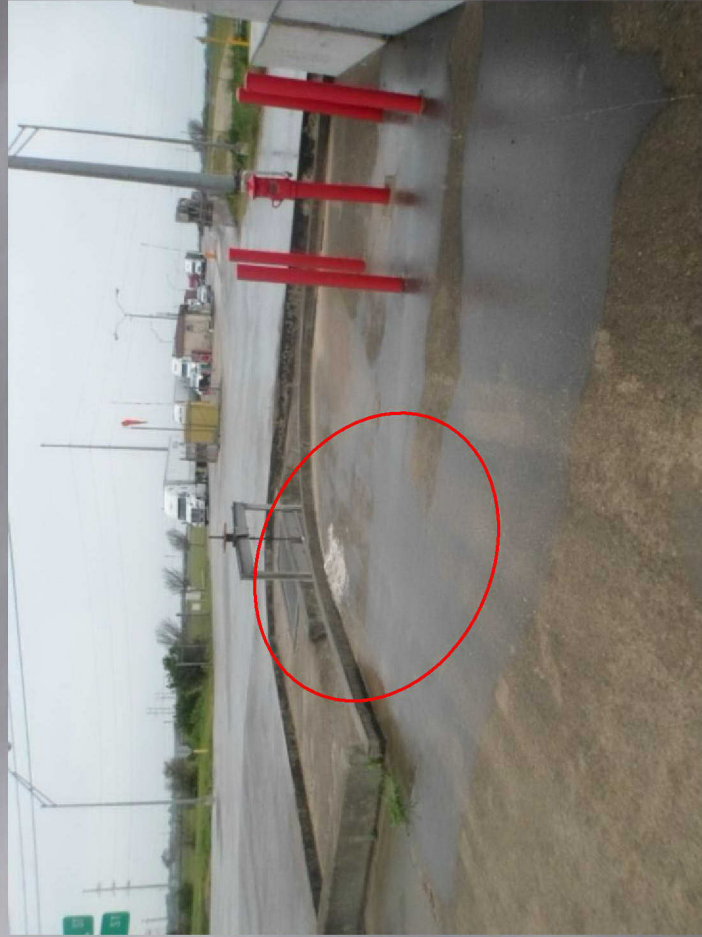
PELLETS THAT HAVE BEEN SWEEP UP BY DIKE WALL, SHOULD BE REMOVED.

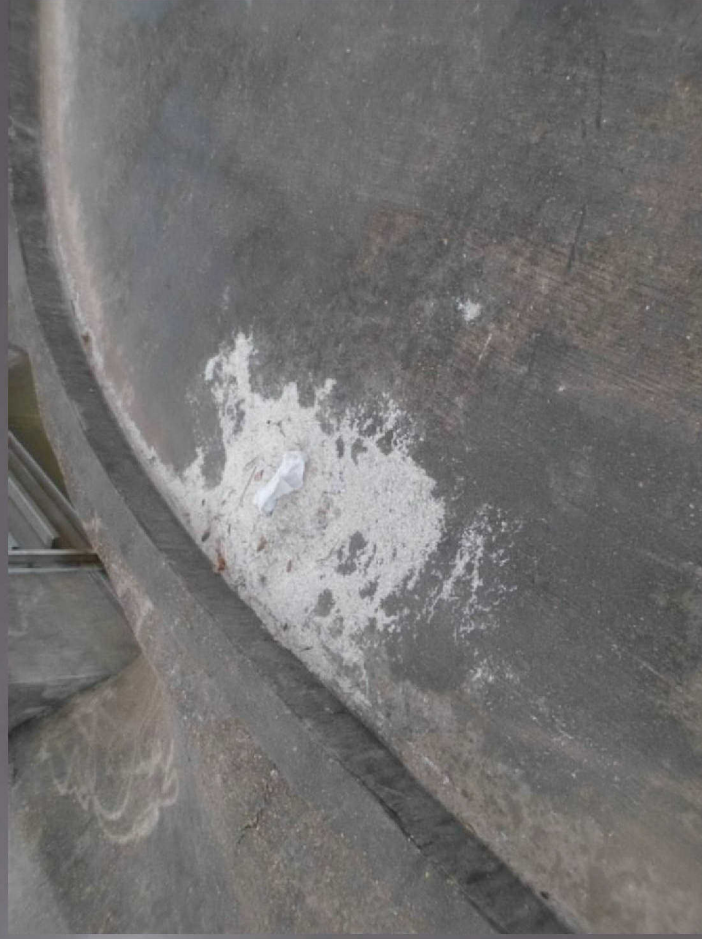
CLOSER IMAGE OF PELLETS. NOTE : NO PELLETS HAVE ENTERED THE DITCH.
