**From:** Porfirio Arguellez III/FTEHSF  
**Sent:** Friday, January 29, 2016 4:41 PM  
**To:** T.P. Tai/TXPO; Jesse Chang/TXLLDPE; Arturo Bazan/FTTRIN; Howard Huang/FTHDSF; Virgil Simms/FTPPOR; S.C. Chang/TXHDPE  
**Cc:** Rick Crabtree/FTOLSF; Matt Brogger/FTEHSF  
**Subject:** Pellet/Powder Gate 2 Road Audit  
**Attachments:** Gate 2 Road Audit 1.29.16.pdf

# FORMOSA PLASTICS CORPORATION, TEXAS

Traffic Pellet/Powder Observations  
Gate 2 Road

Conducted: January 29, 2016

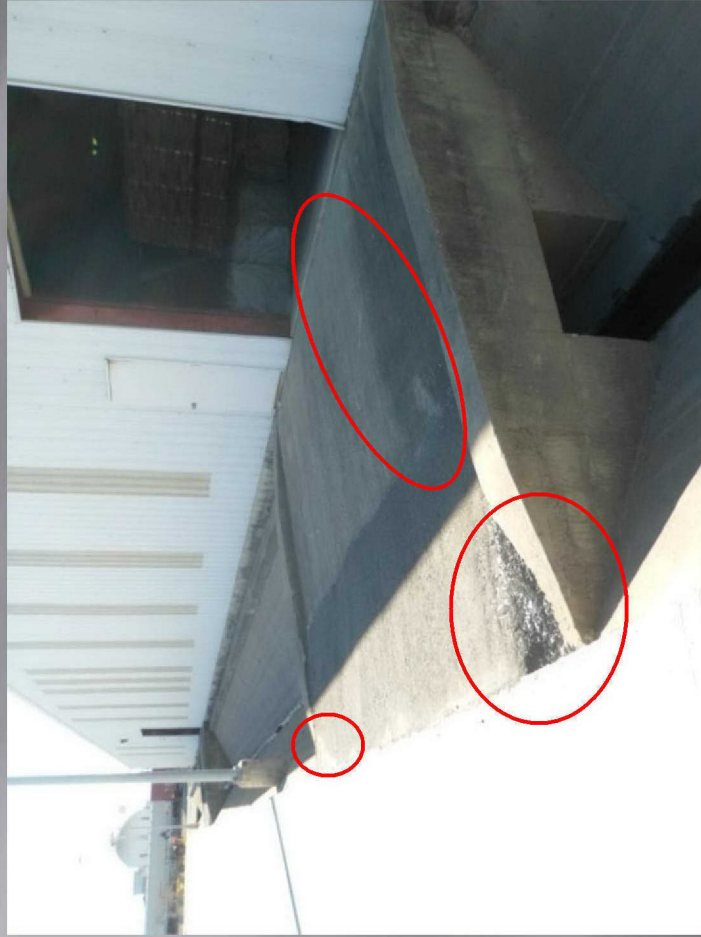
# PEI / PPI Bagging Area

FIRST ENTRANCE ON THE EAST SIDE OF BUILDING, PELLETS ARE VISIBLE ON THE PAVEMENT. CORNERS OF THIS ENTRANCE HAVE THE MOST AMOUNT OF PELLETS THAT HAVE ACCUMULATED IN THE CRACKS OF PAVEMENT.

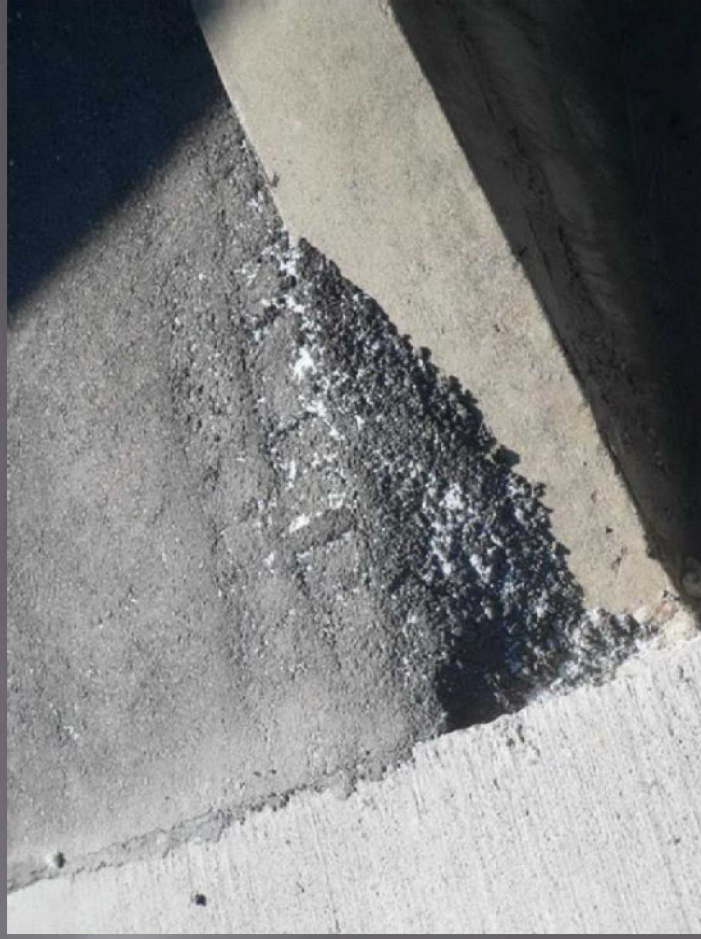
CLOSER IMAGE OF THE CORNER OF THE ENTRANCE.

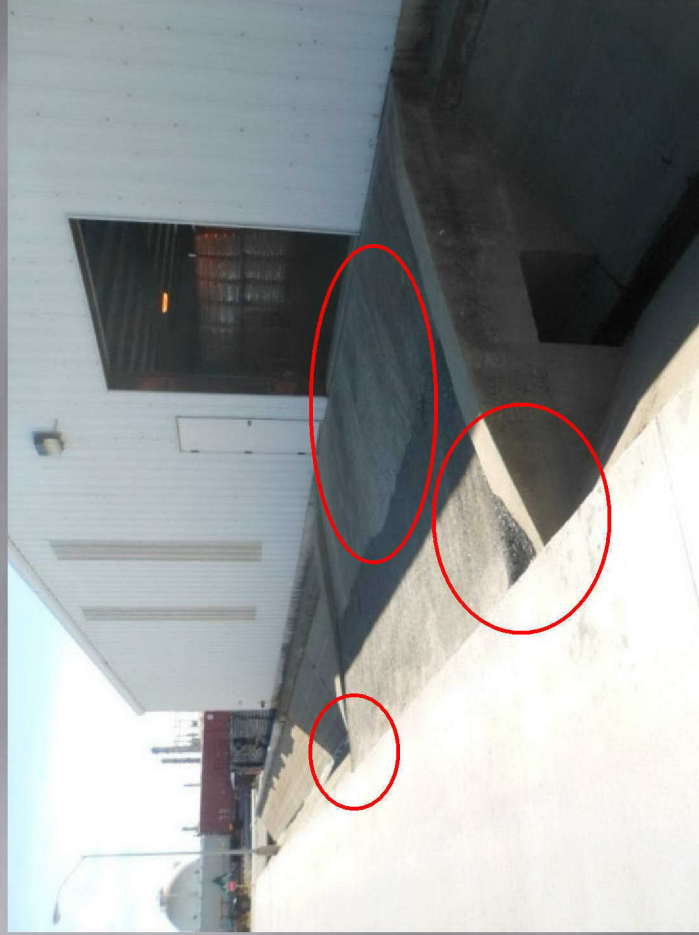
# PEI / PPI Bagging Area

SECOND ENTRANCE ON THE EAST SIDE, IS THE SAME AS THE FIRST ENTRANCE. PELLETS ARE OBSERVED ON THE PAVEMENT.

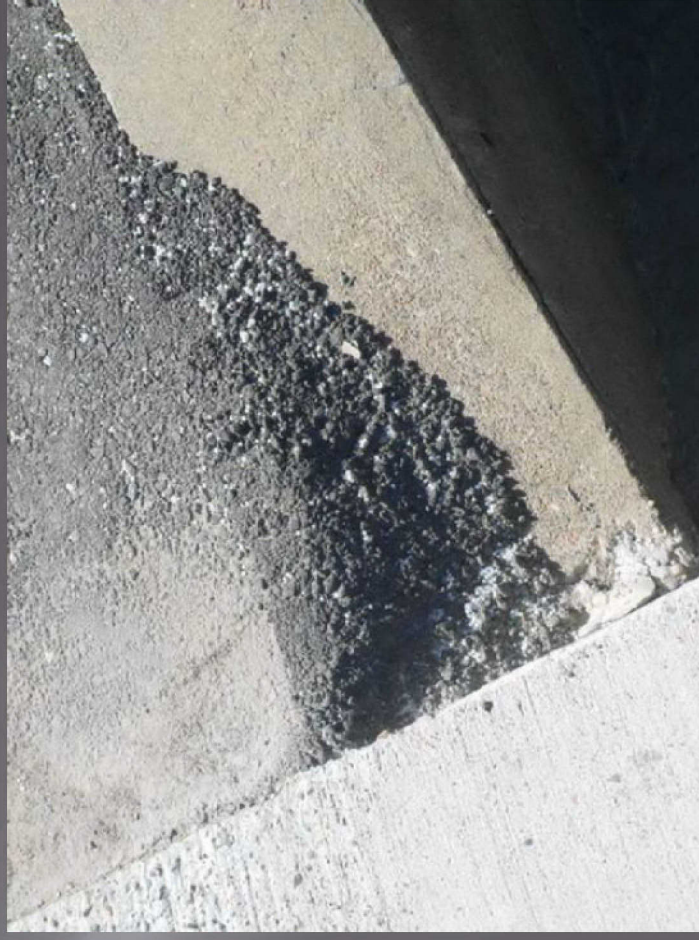
CLOSER IMAGE OF THE PAVEMENT.

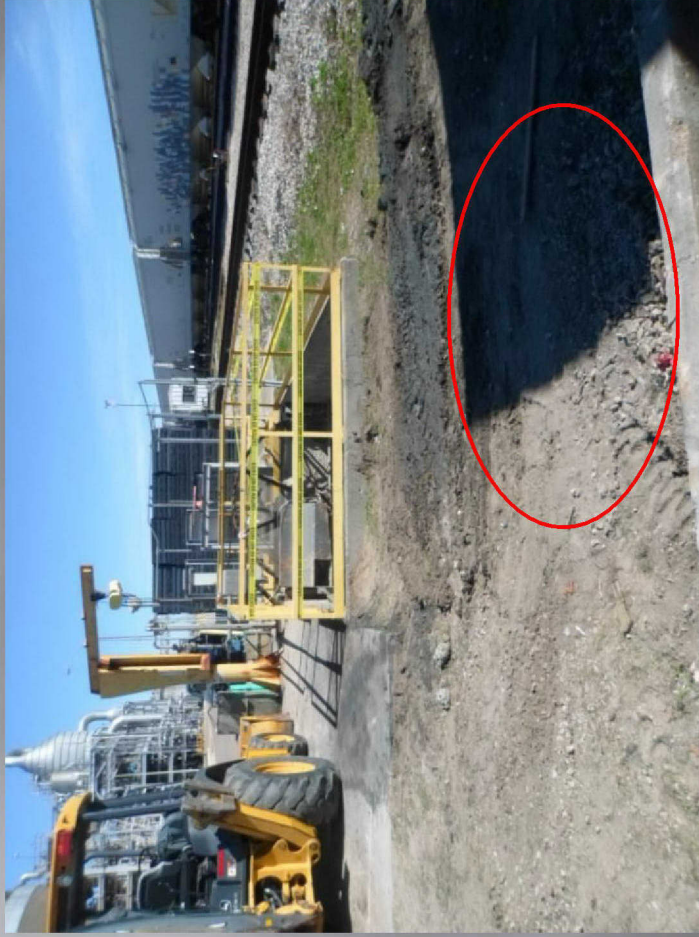
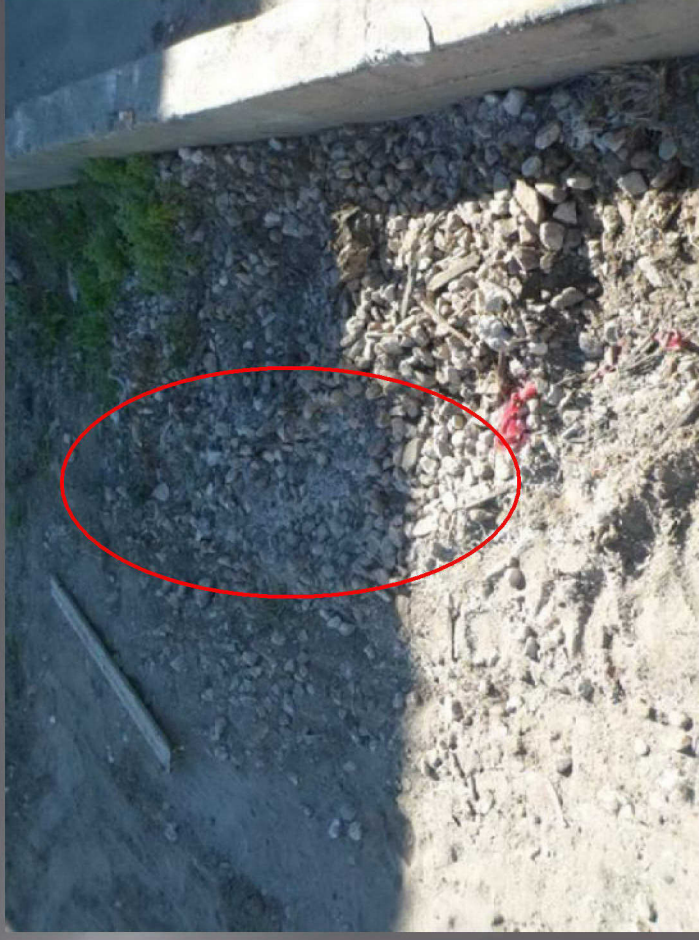
# PE1/PP1 Bagging Area

IN THE ARE IN FRONT OF THE WEIR, PELLETS ARE OBSERVED IN A PILE OF ROCKS. NEXT PHOTOS SHOW CLOSER IMAGES.

VIEW OF PELLETS AND ROCKS.

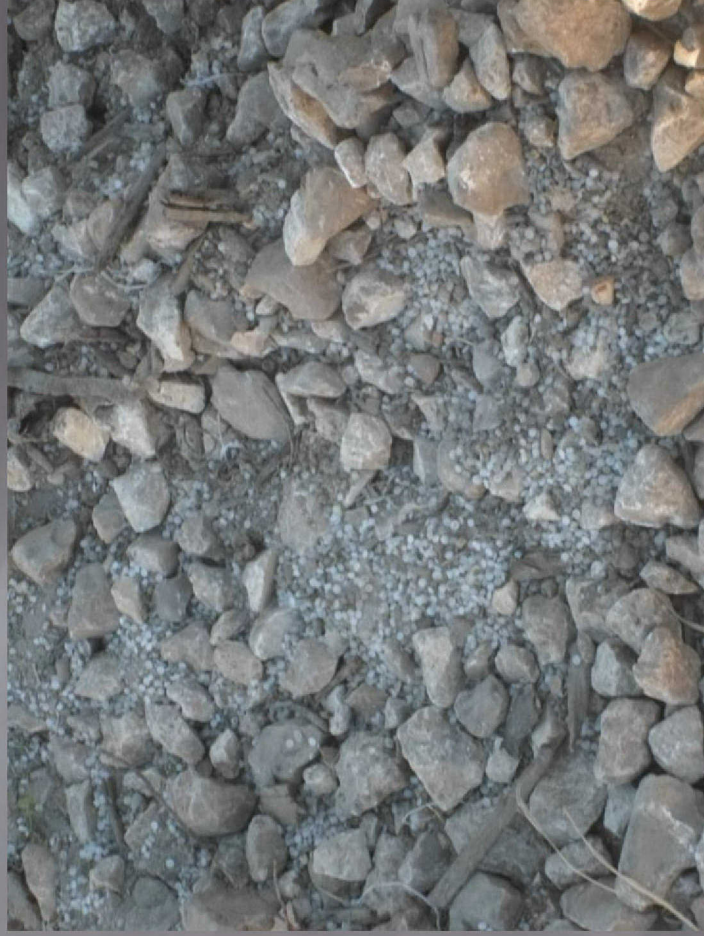
# PEI/PP1 Bagging Area

CLOSER IMAGE OF PELLETS.

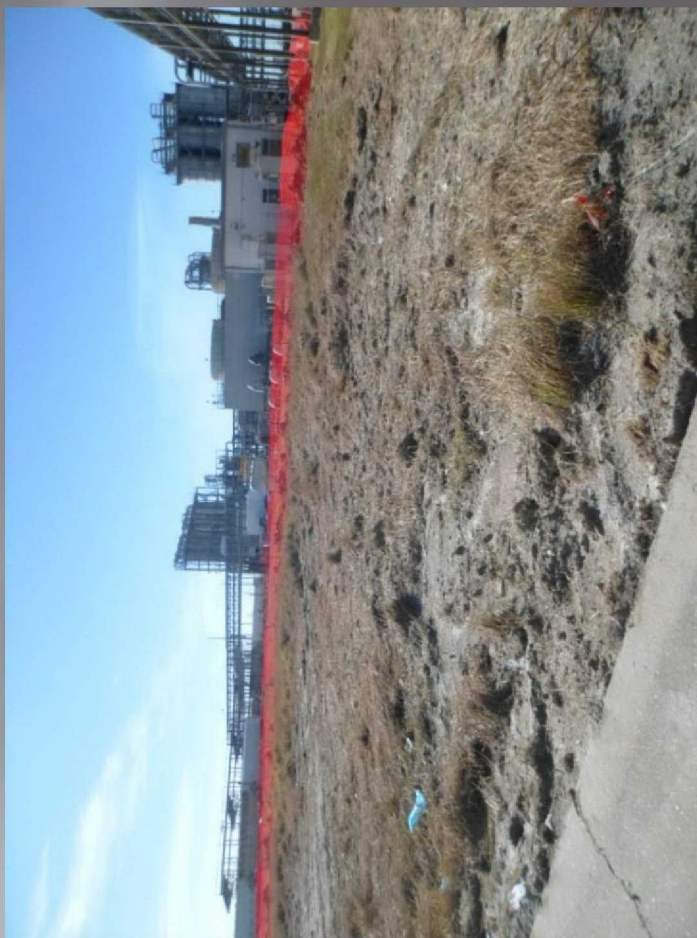
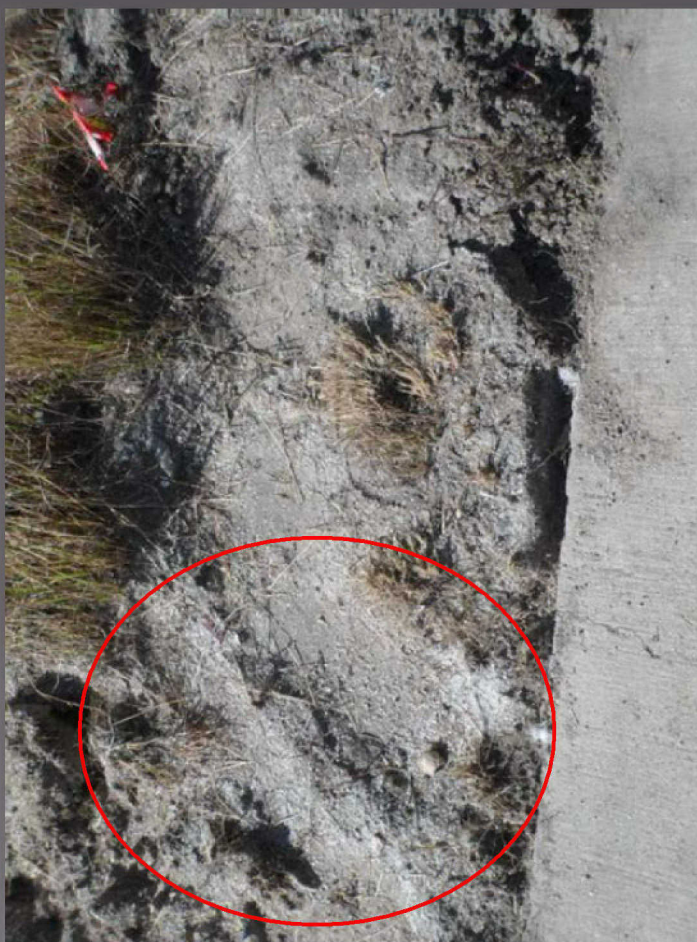
# PP 2

PELLETS ARE SCATTERED THROUGHOUT THIS AREA.  
NEXT IMAGES SHOW A FEW AREAS CLOSE TO THE  
CONCRETE DITCH.

CLOSER IMAGE OF PELLETS.

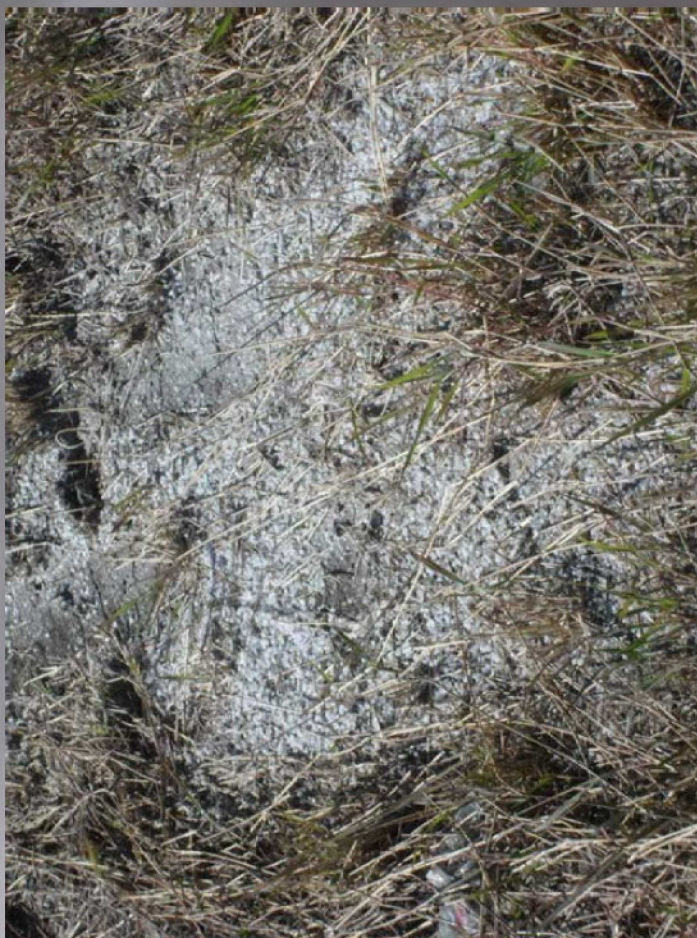
# PP 2

PELLETS OBSERVED IN GRASS AREA.

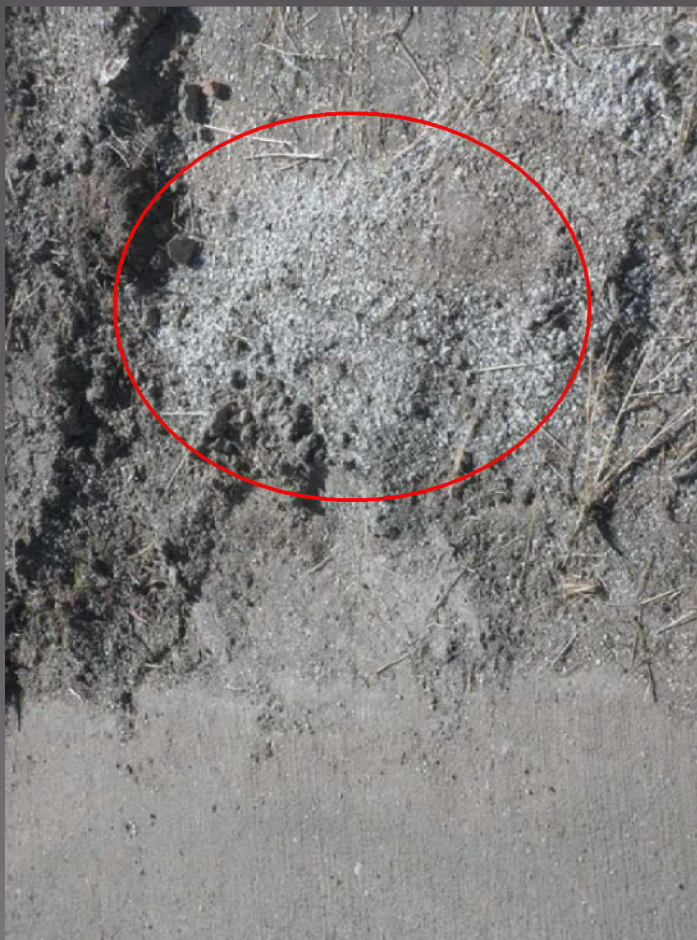
CLOSER IMAGE OF PELLETS.

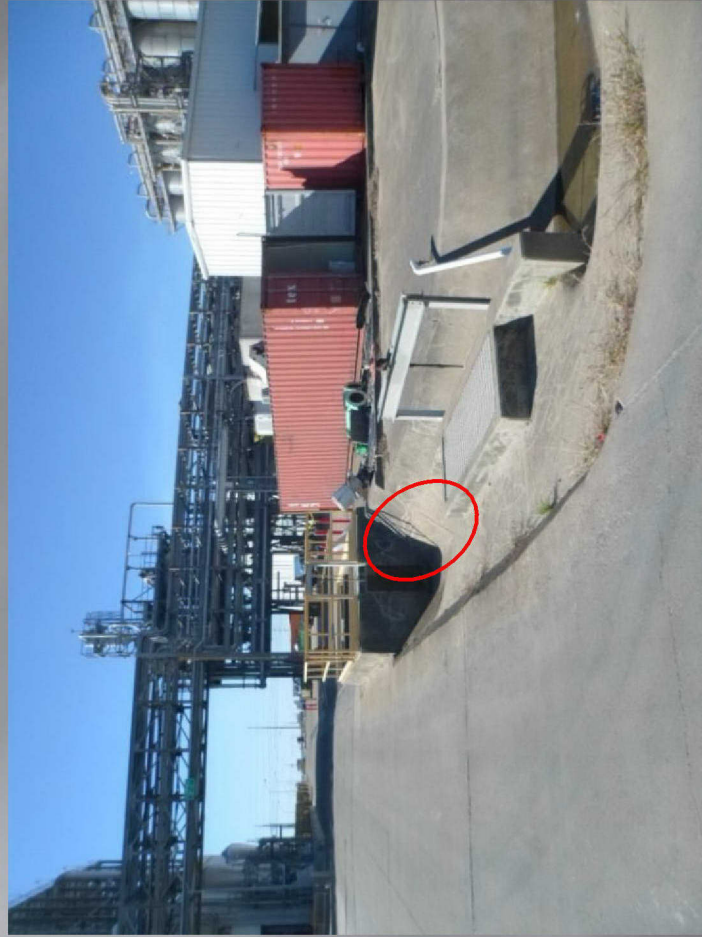
# LLDPE

SMALL AMOUNTS OF PELLETS ARE OBSERVED IN THE DITCH JUST DOWNSTREAM OF THE GATE. NEXT TWO PHOTOS SHOW CLOSER IMAGES.

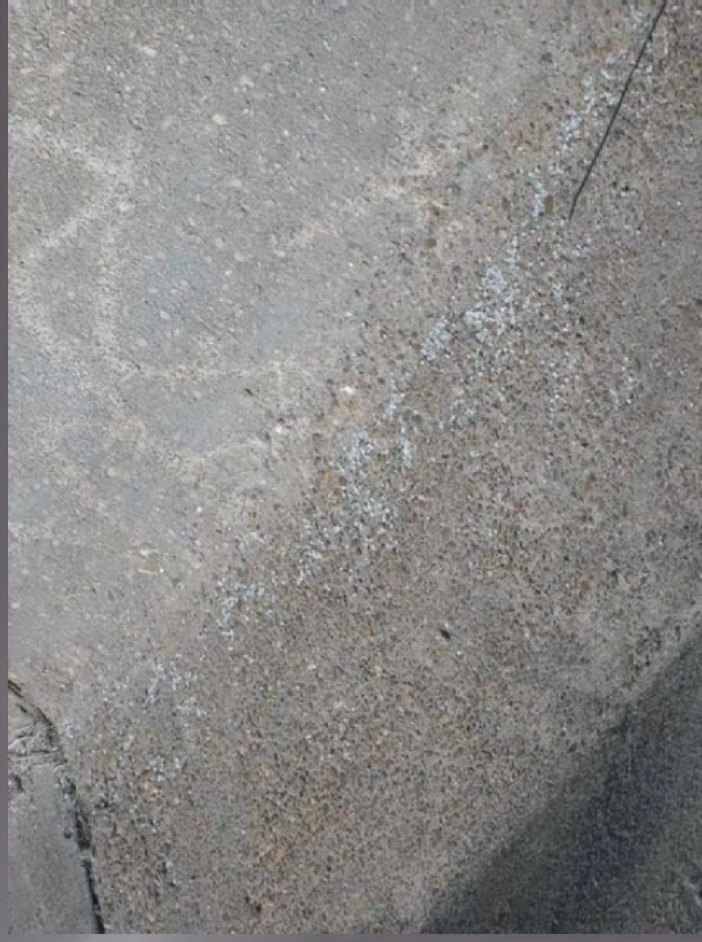
PELLETS ARE OBSERVED ON PAVEMENT. NOTE THAT PAVEMENT HAS CRACKS AND CHIPS, MOST THE PELLETS ARE OBSERVED IN THESE AREAS.

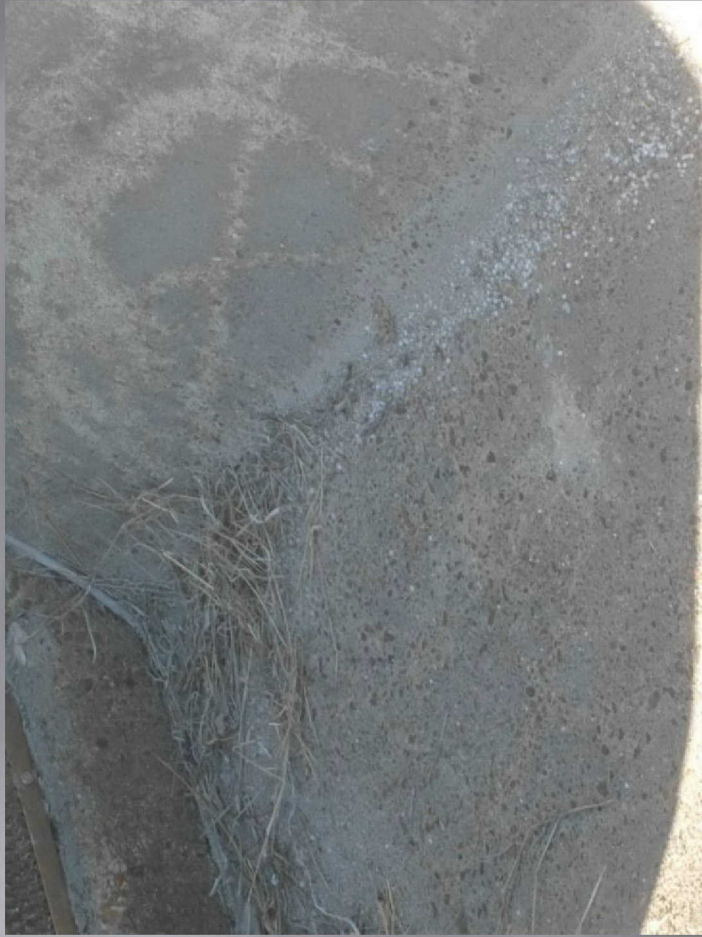
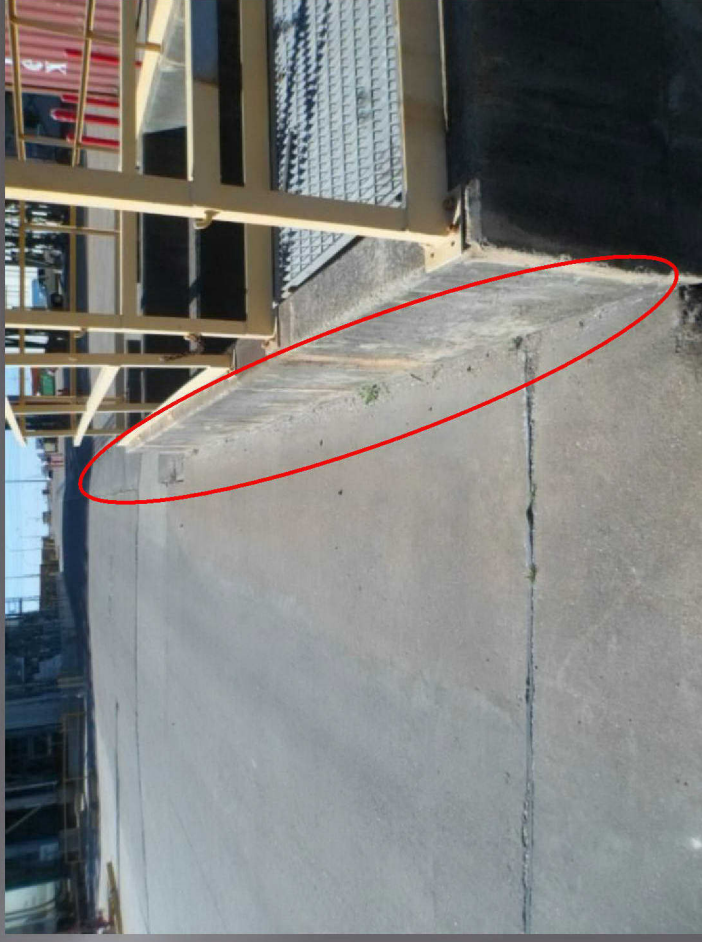
# LLDPE

ADDITIONAL PHOTO WHICH SHOWS PELLETS.

ALONG THIS WALL ON THE STREET, PELLETS ARE OBSERVED, AGAIN PELLETS ARE ABLE TO BE SEEN IN CRACKS ON THE STREET IN THIS AREA.

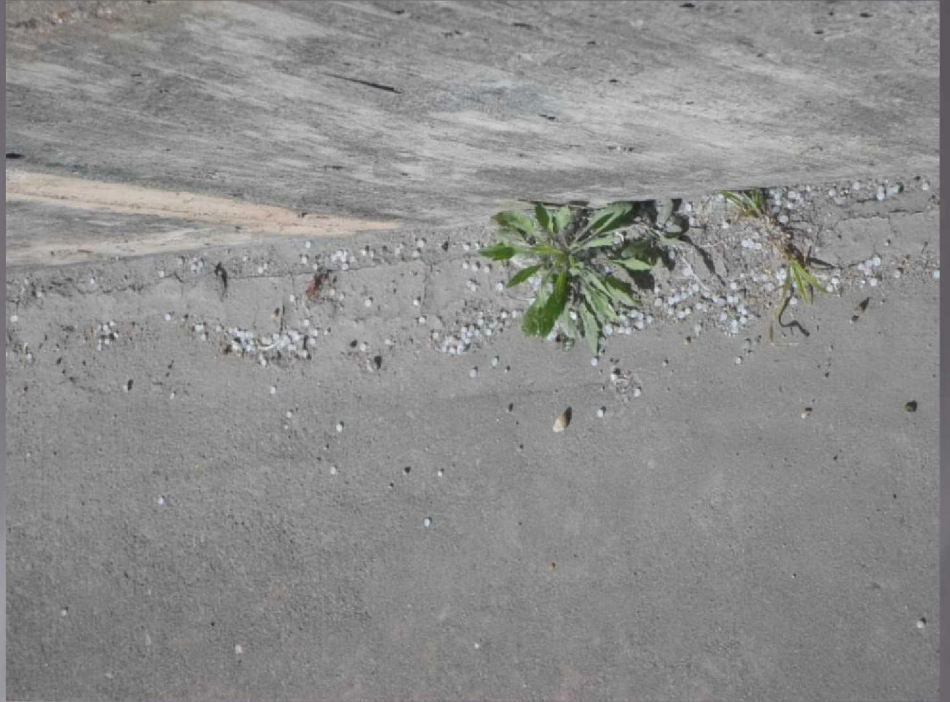
# LLDPE

CLOSER IMAGE FROM PREVIOUS PHOTO.

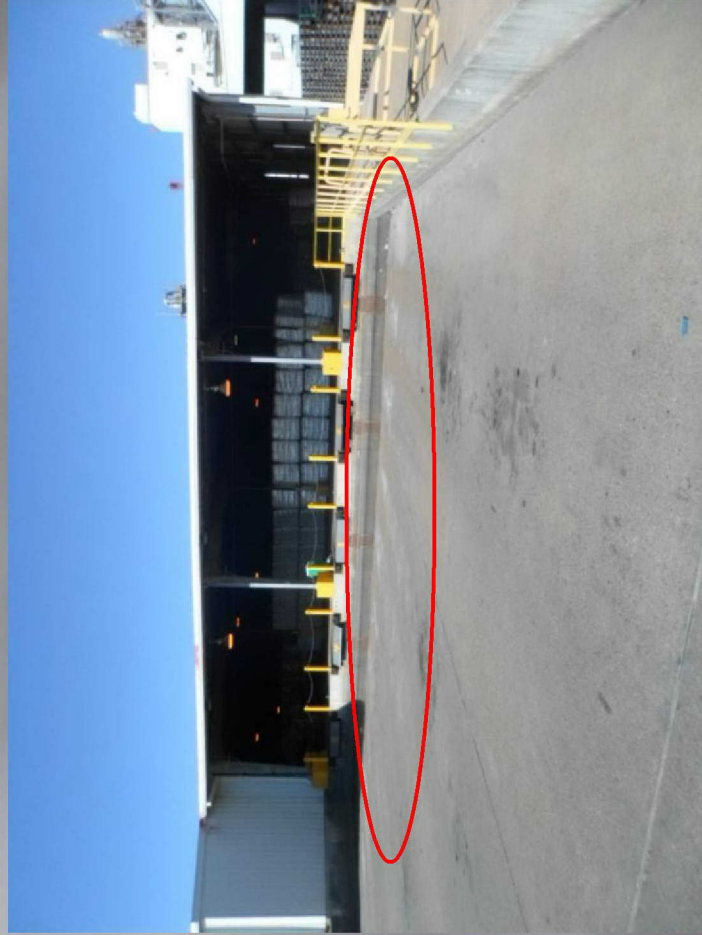
# LLDPE WAREHOUSE

CLOSER IMAGE OF PELLETS IN LOADING AREA.

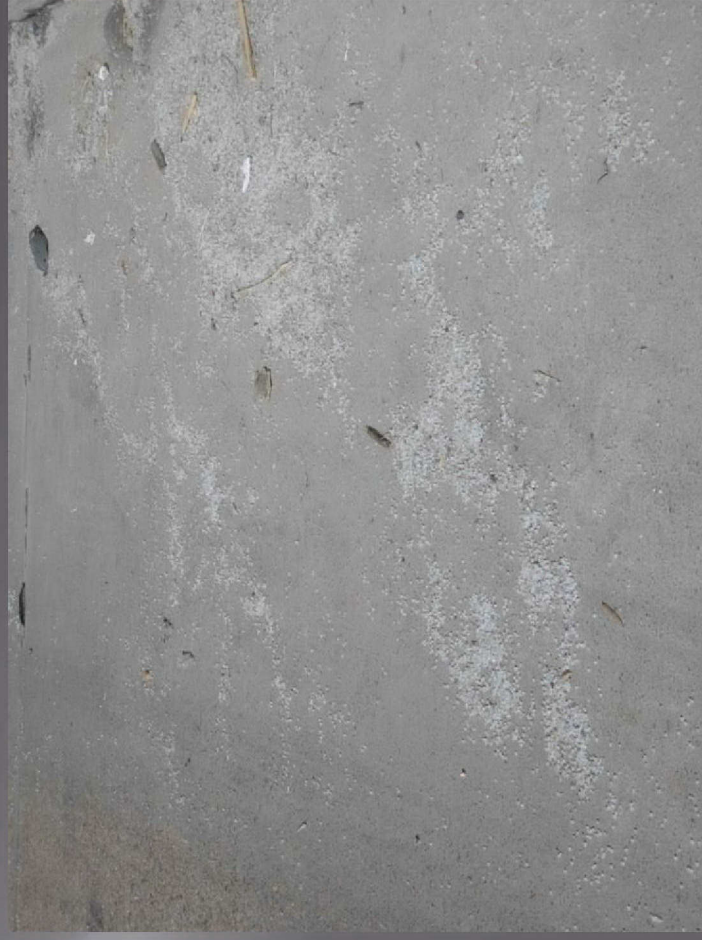
TRUCK LOADING AREA, PELLETS ARE OBSERVED ON PAVEMENT. THERE IS GRATING UP AGAINST THE WALL OF THE LOADING AREA. SEEMS THERE IS ALSO DRAINAGE ISSUES, POSSIBLY WITH GRATING BEING OBSTRUCTED WITH DEBRIS.

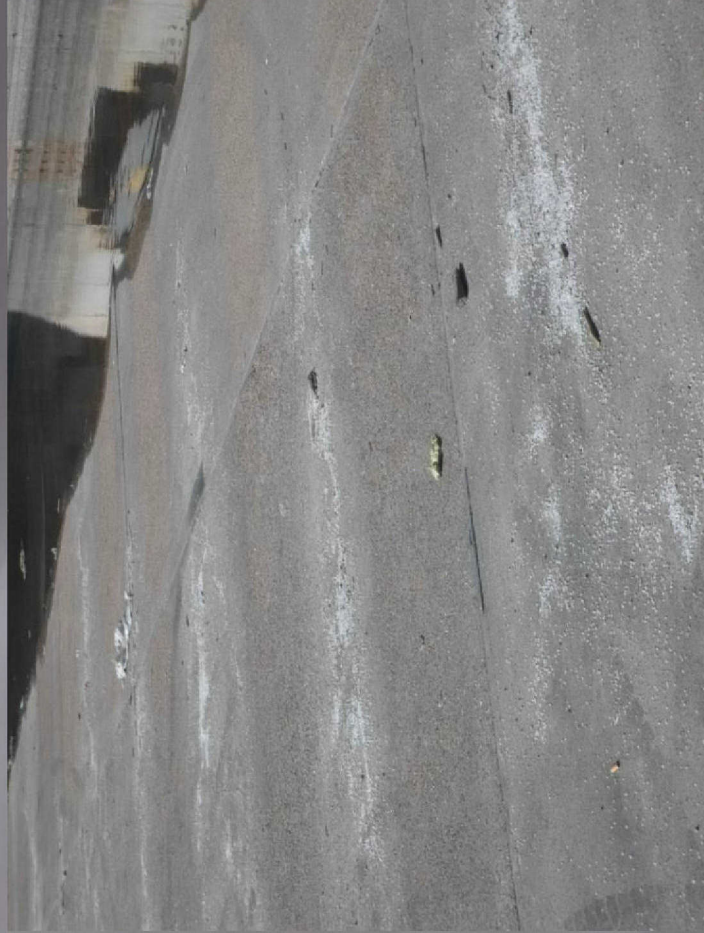
# LLDPE WAREHOUSE

ADDITIONAL PHOTO OF PELLETS ON PAVEMENT.
