Project Name: Formosa Plastics Remediation: Cox Creek Phase 1
Customer: FNI
Location: Point Comfort, TX

Project No. E8999	DAILY LOG	DATE	1/12/2023
		DAY	Thursday
		NO.	57

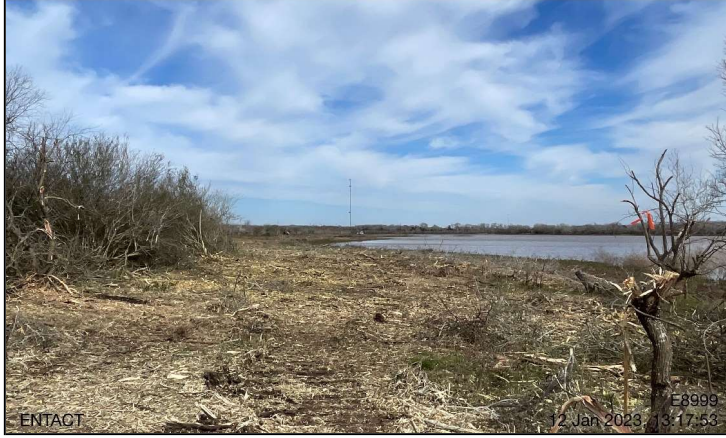
Photo 1. Photo of area cleared by CIMAF.

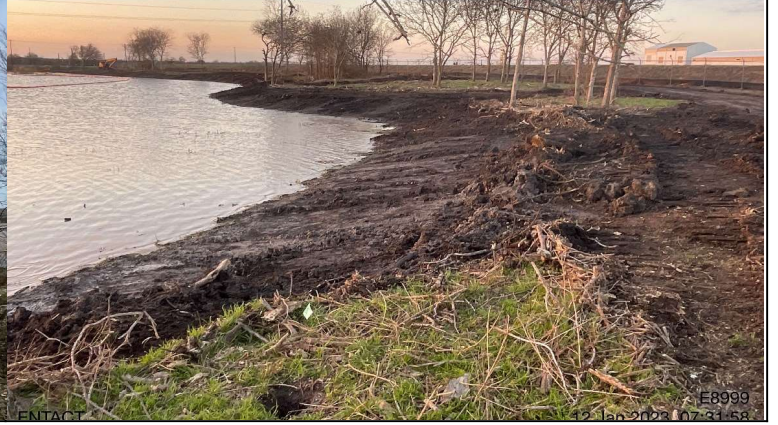
Photo 2. Photo of excavated surface in AOC 14.

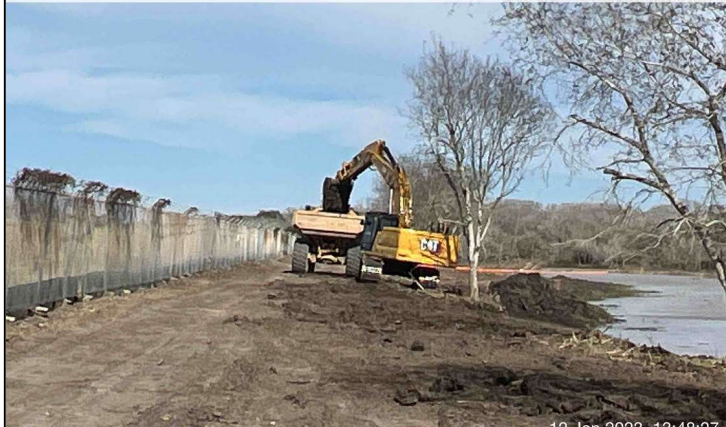
Photo 3. Photo of excavator loading haul truck in AOC 14.

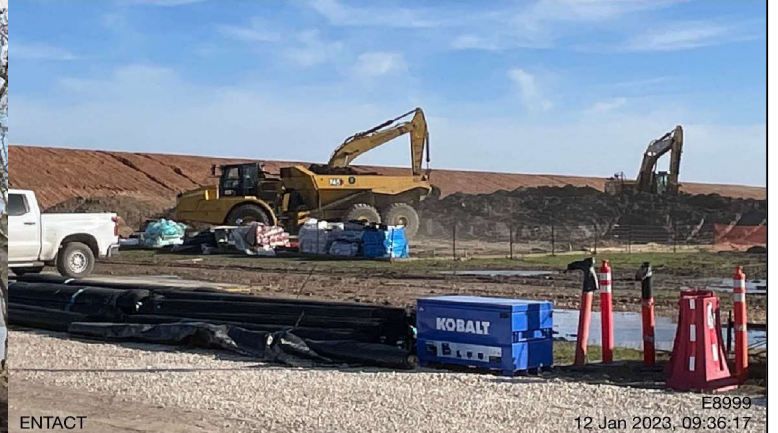
Photo 4. Photo of haul truck offloading excavated material in staging area #1.
