IWD_WQ0002436000_Compliance_20180411_CP Texas Commission on Environmental Quality Investigation Report

Investigation # 1484116

Program(s): WASTEWATER

Investigation Type: Compliance Investigation

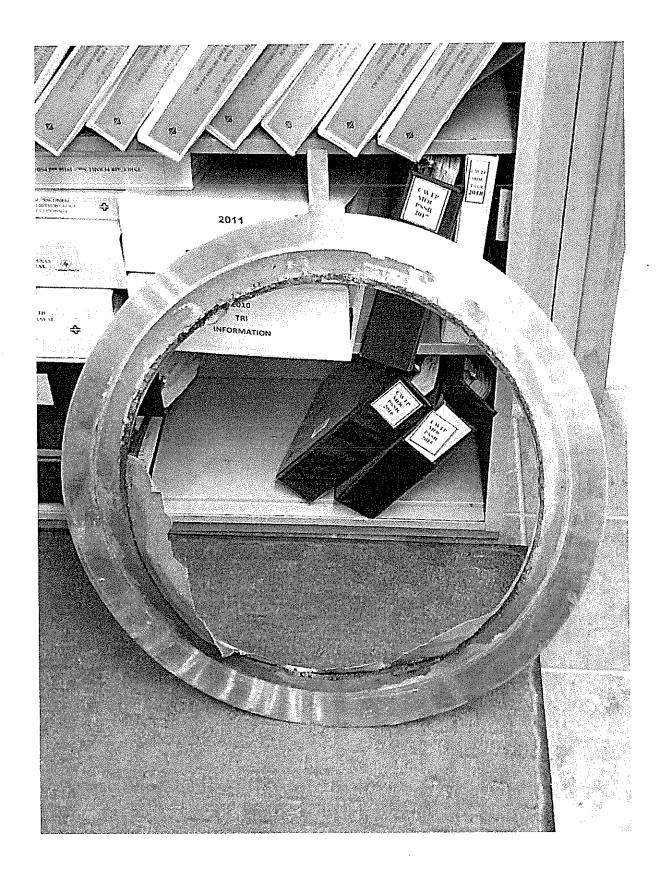
Cone Filter Damage

The cone filter was damaged on two separate occasions. The damage consisted of the filter section of the cone being removed completely. See Attachment 2 for picture.

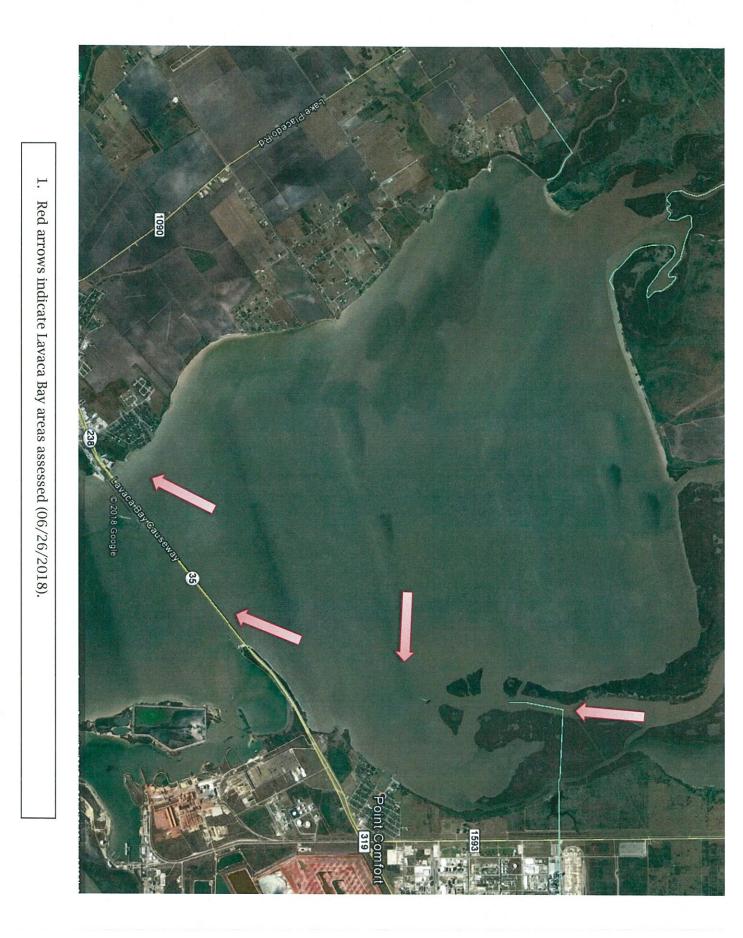
Formosa Plastics Corporation, Texas - CN600130017 WQ0002436000 Photo by Zack Fuqua under partly cloudy skies.	22-Jun-18	201 FORMOSA DR,POINT COMFORT, TX, 77978 Investigation No. 1484116	Texas, 77978 Photograph No. 1: Outfal 001 Discharge Lavaca Bay	<image/>
Formosa Plastics Corporation	Formosa Point Comfort Plant	201 FORMOSA DR,POINT	Point Comfort, Texas, 77978
